Subject: Department of Natural Resources Washington Geological Survey,  
School Seismic Safety Assessment Project, Contract No. AE 410 -  
Seismic Evaluation for **Vashon Island School District**

1. Vashon Island High School, Building D – Gymnasium
2. Vashon Island High School, Building K – Annex

Building Name:	Building D - Gymnasium
Facility Name:	Vashon Island High School
District Name:	Vashon Island
ICOS Latitude:	47.423
ICOS Longitude:	-122.457
ICOS	
County/District ID:	17402
ICOS Building ID:	20350
ASCE 41 Bldg Type:	RM1
Enrollment:	596
Gross Sq. Ft. :	23,744
Year Built:	1961
Number of Stories:	3
S <sub>XS</sub> BSE-2E:	1.049
S <sub>X1</sub> BSE-2E:	0.565
ASCE 41 Level of Seismicity:	High
Site Class:	C
V <sub>S30</sub> (m/s):	375
Liquefaction Potential:	very low
Tsunami Risk:	Extremely Low
Structural Drawings Available:	some
Evaluating Firm:	BergerABAM/WSP

Building Name:	Building K - Annex
Facility Name:	Vashon Island High School
District Name:	Vashon Island
ICOS Latitude:	47.423
ICOS Longitude:	-122.457
ICOS	
County/District ID:	17402
ICOS Building ID:	20352
ASCE 41 Bldg Type:	W2
Enrollment:	596
Gross Sq. Ft. :	4,677
Year Built:	1963
Number of Stories:	1
S <sub>XS</sub> BS

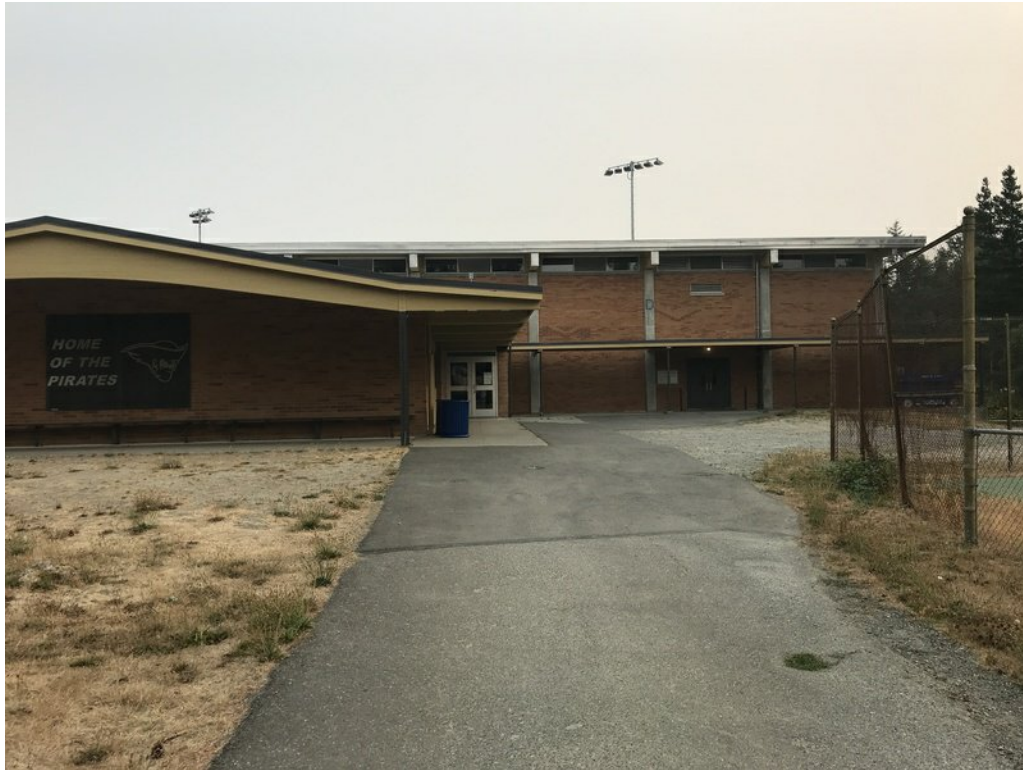
**Figure 1-1. Vashon HS Gym South wall**

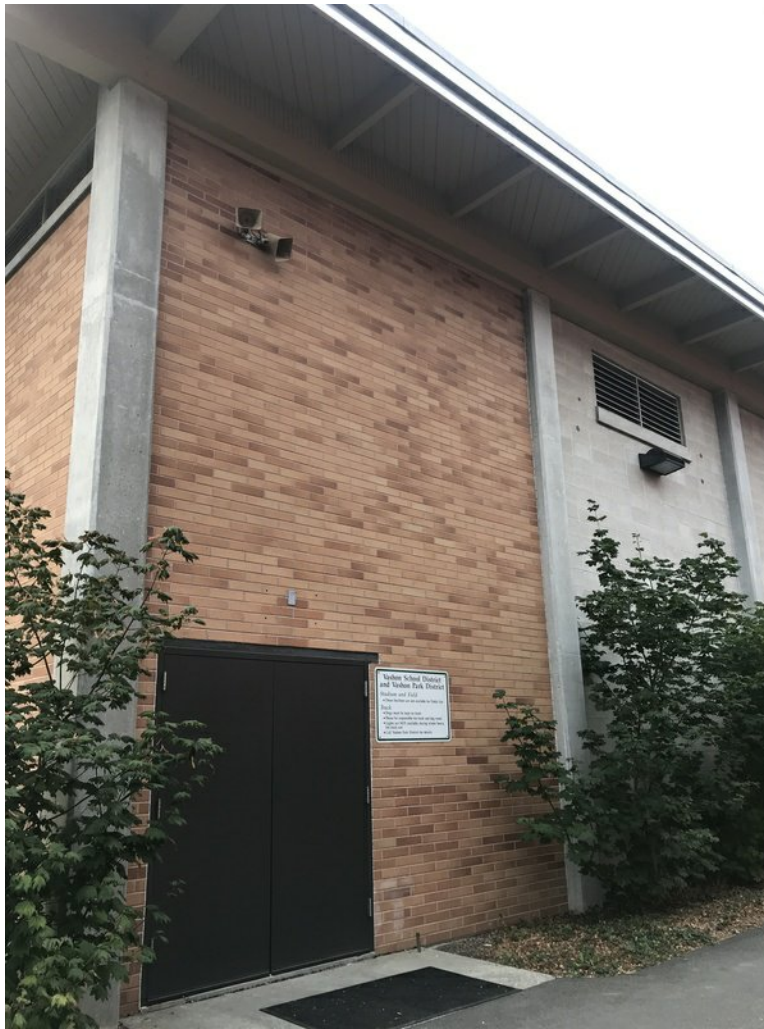
Figure 1-2. Vashon HS Gym West wall

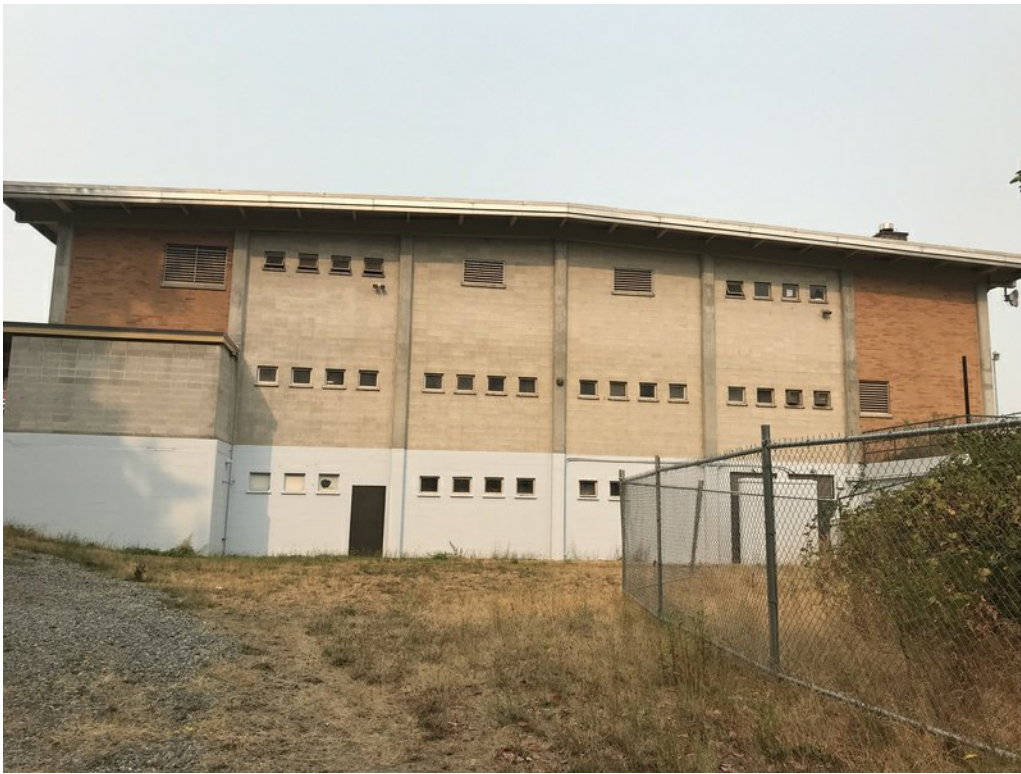
**Figure 1-3. Vashon HS Gym East wall (three-story)**

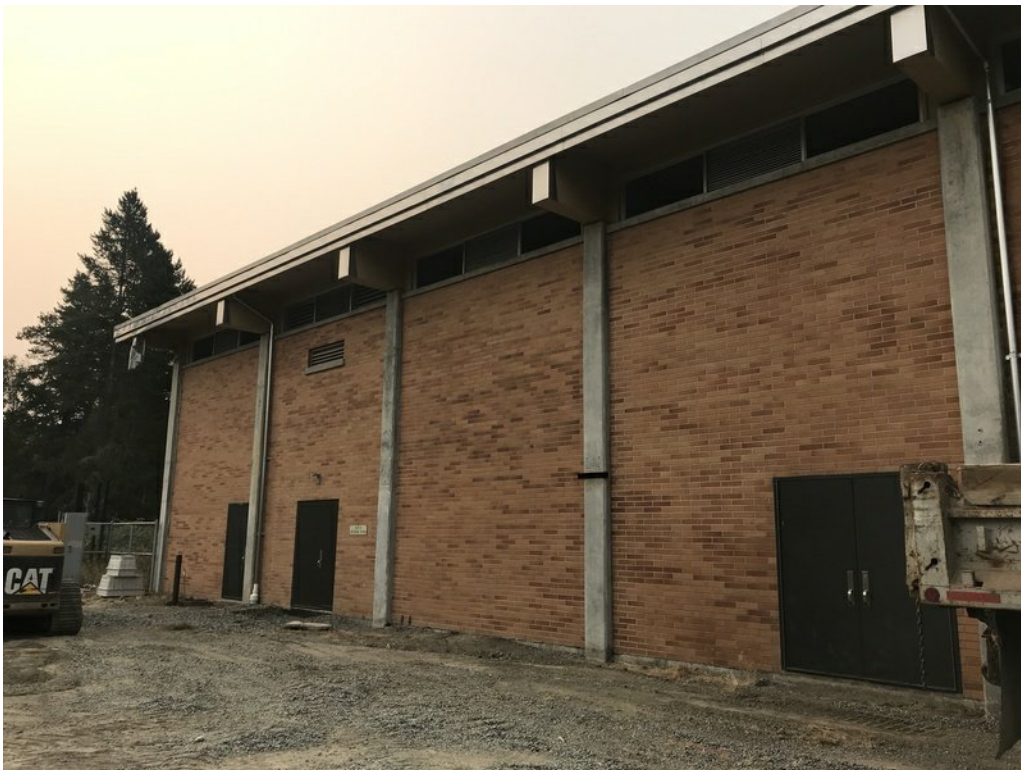
**Figure 1-4. Vashon HS North Gym wall**

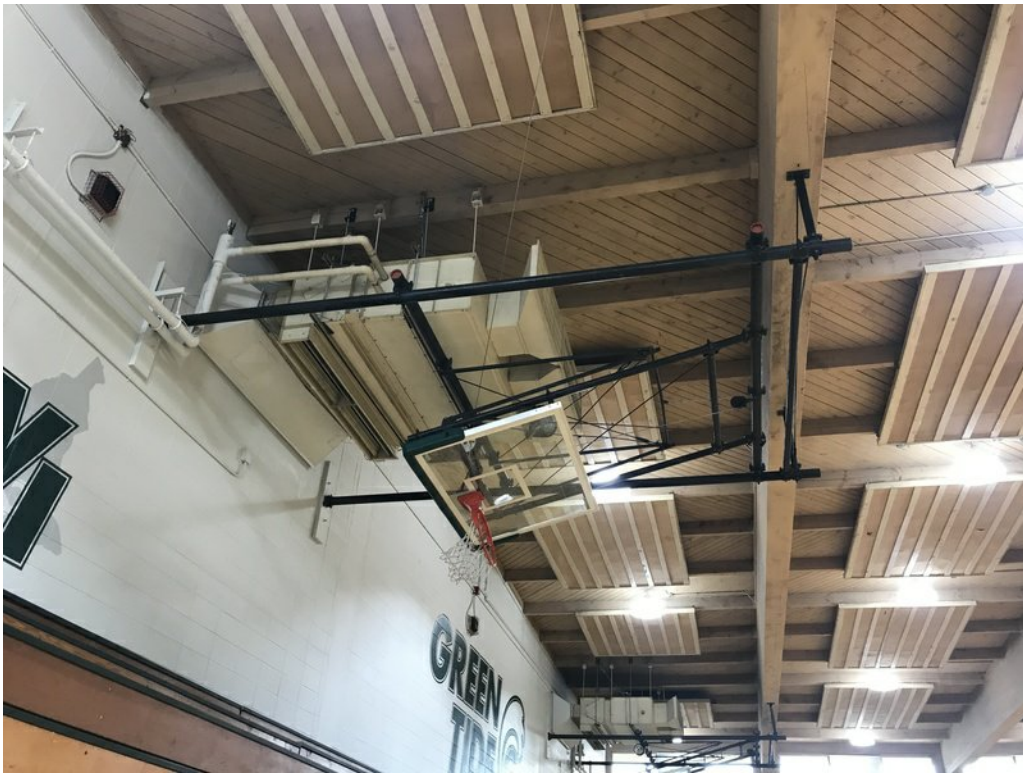
Figure 1-5. Overhead AHU

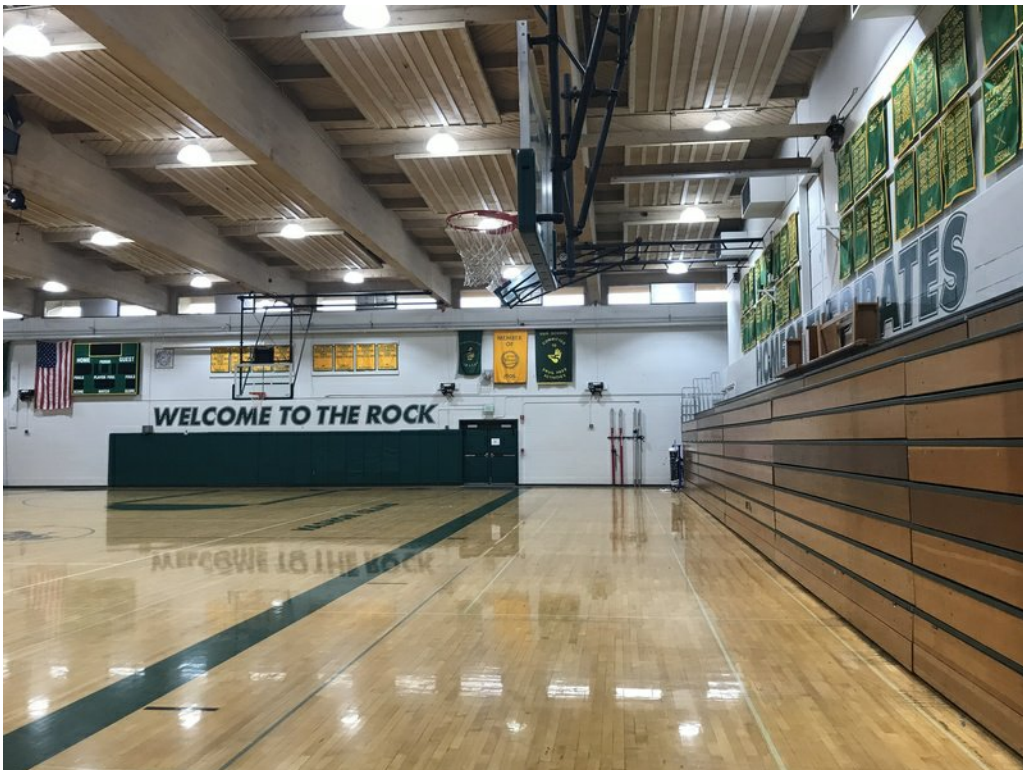
Figure 1-6. Gym roof with wood beams, 4x10 purlins and diagonal shiplap sheathing

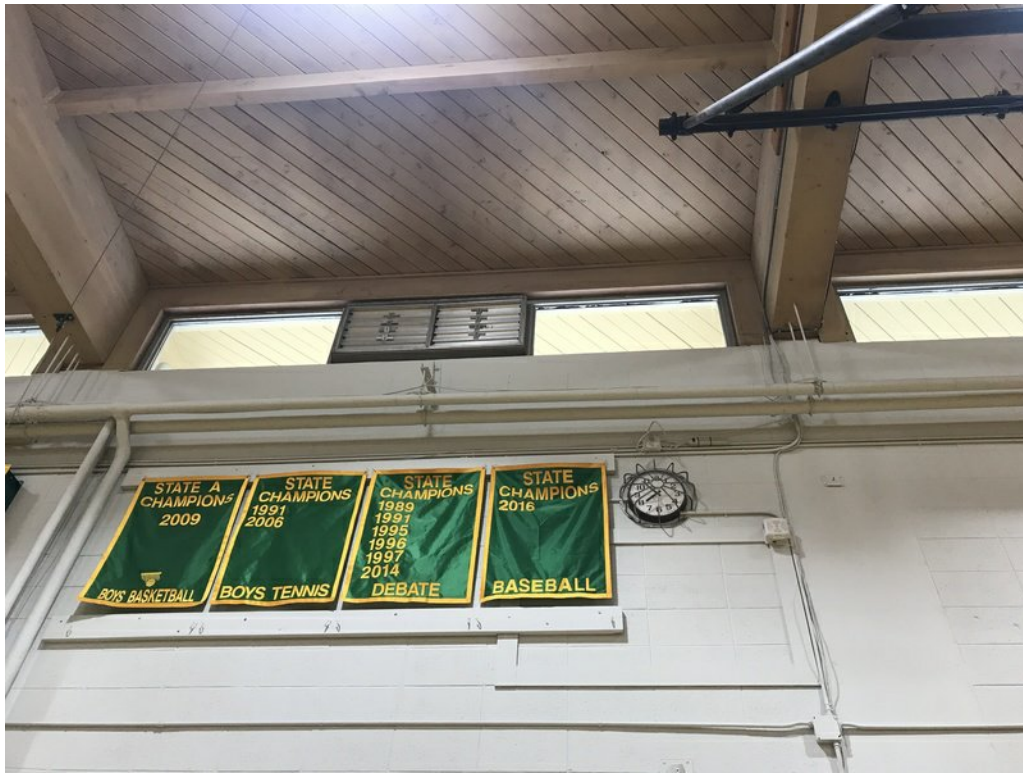
Figure 1-7. Clerestory with windows and louvers

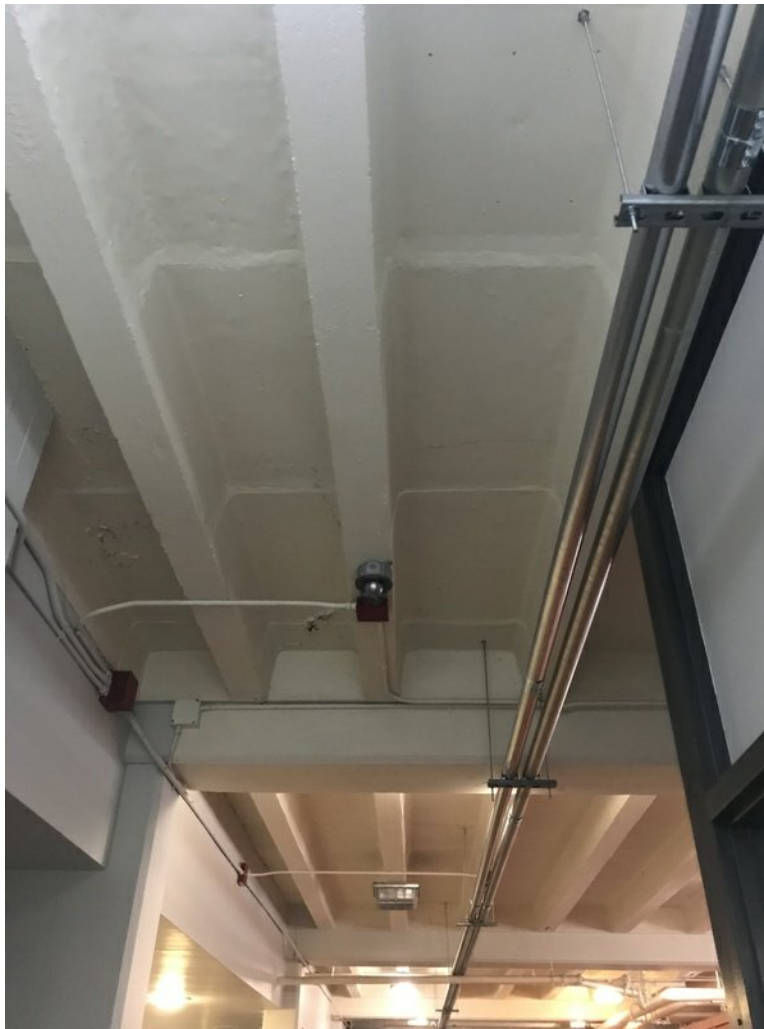
**Figure 1-8. Main floor framing (concrete floor joists and beams)**

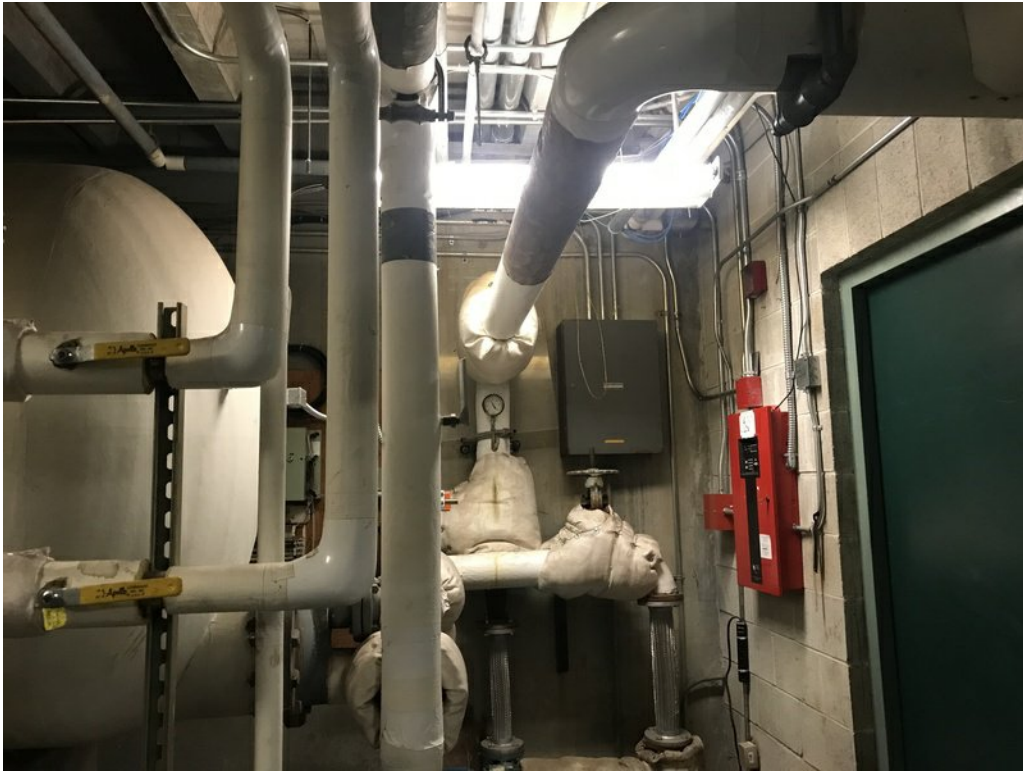
Figure 1-9. Mechanical room

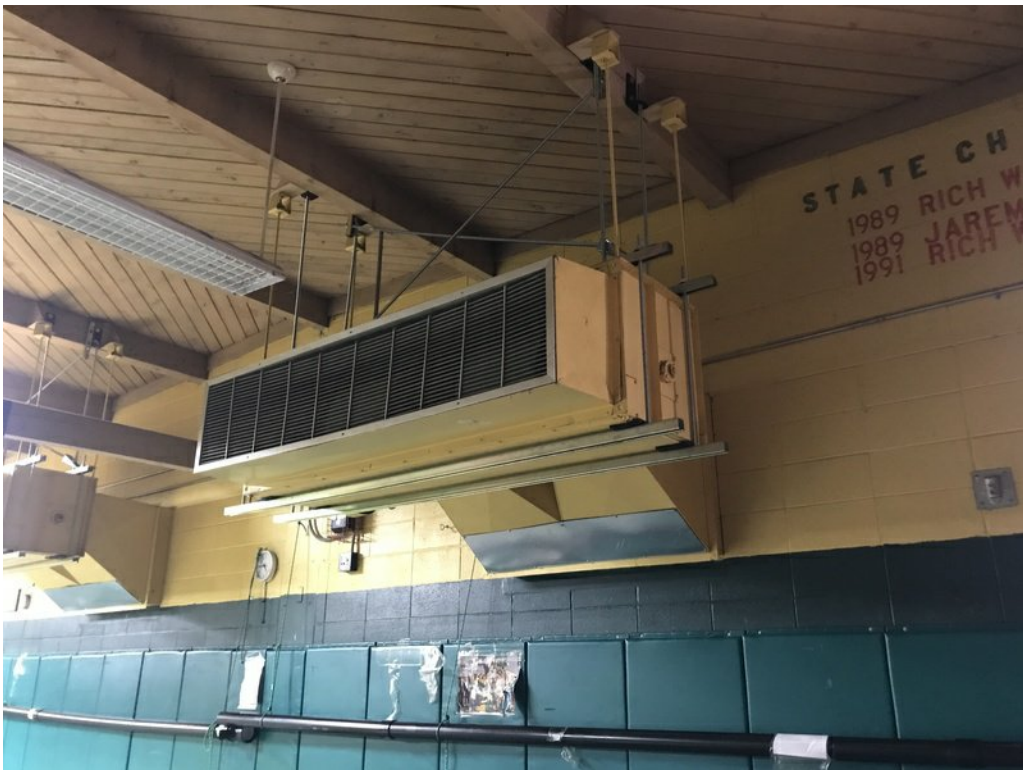
Figure 1-10. Recent HVAC upgrade with bracing

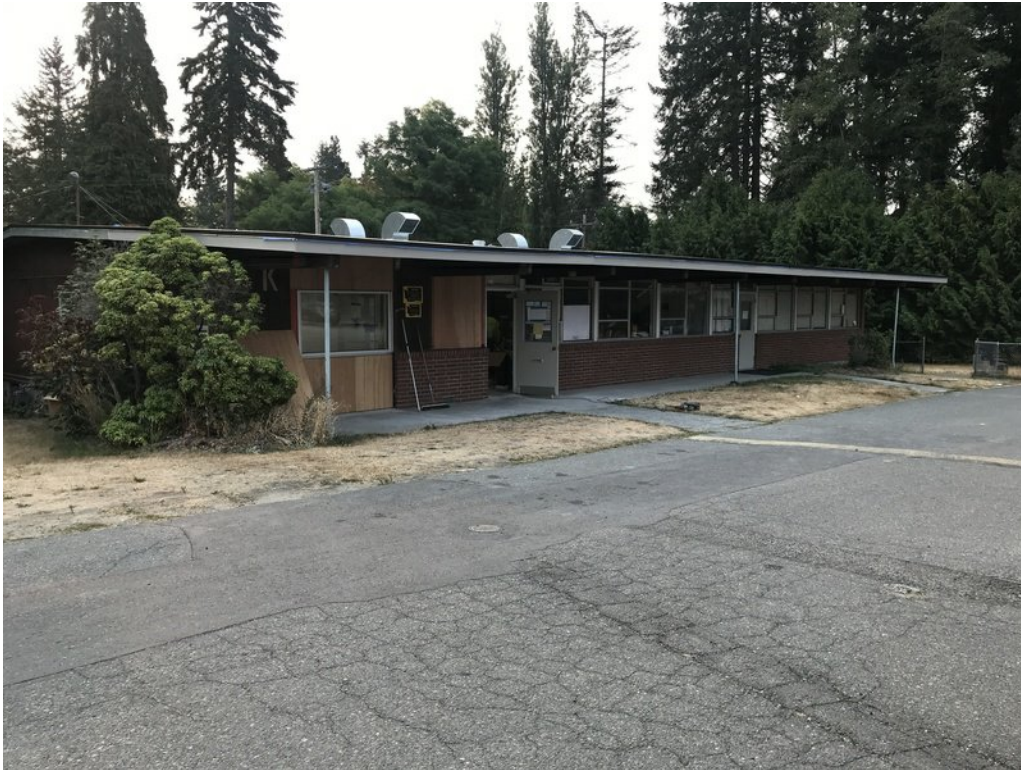
**Figure 1-1. Building K - West face**

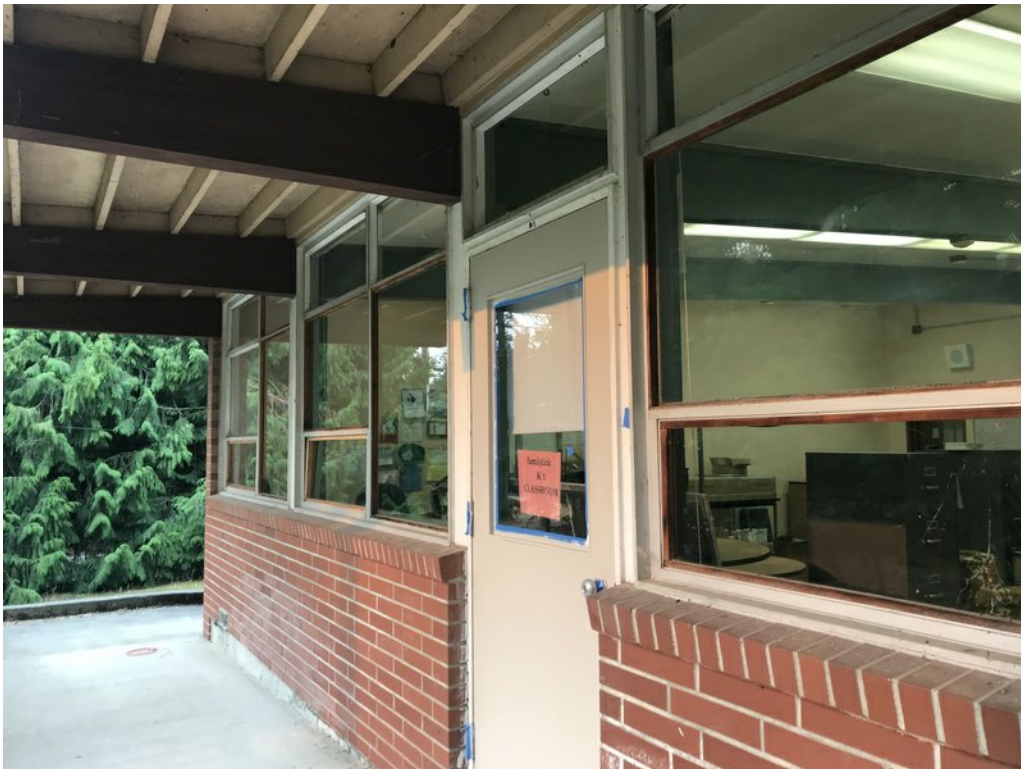
**Figure 1-2. West wall exterior**

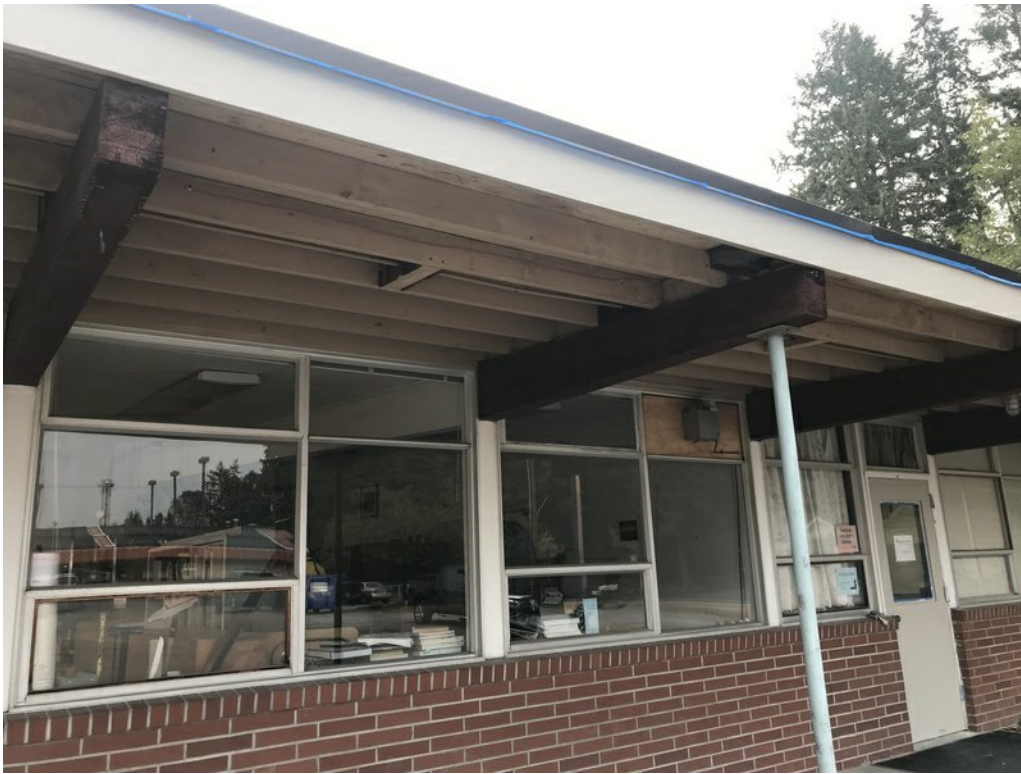
**Figure 1-3. Covered exterior sidewalk**

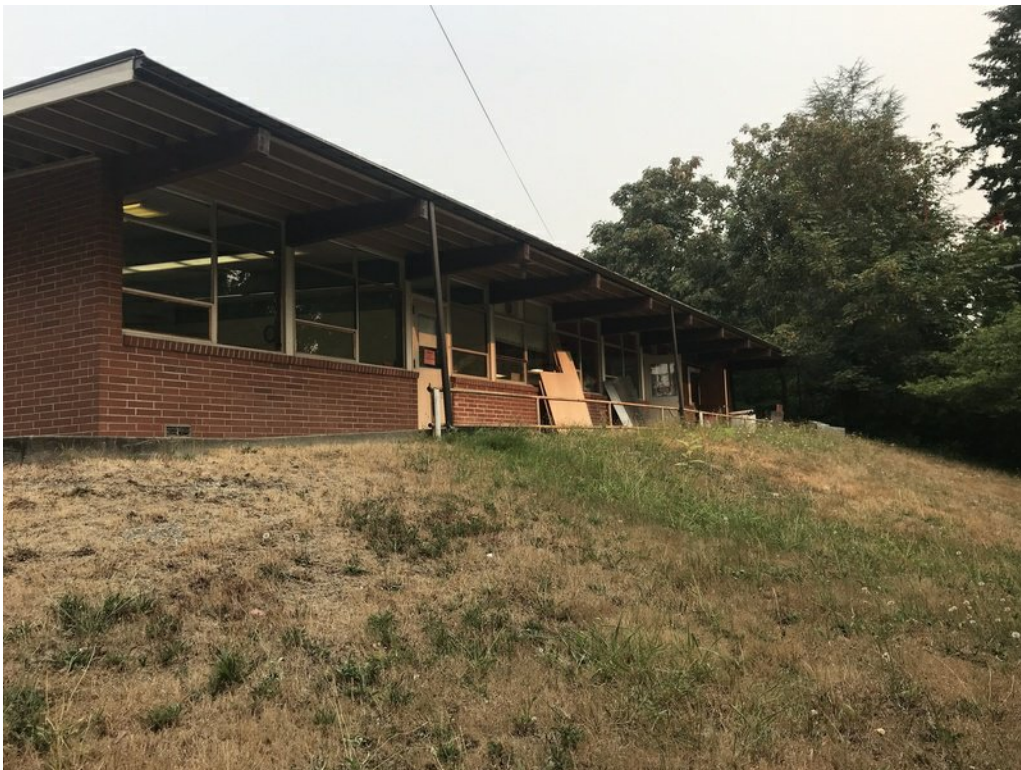
**Figure 1-4. East wall - grade slopes away from building**

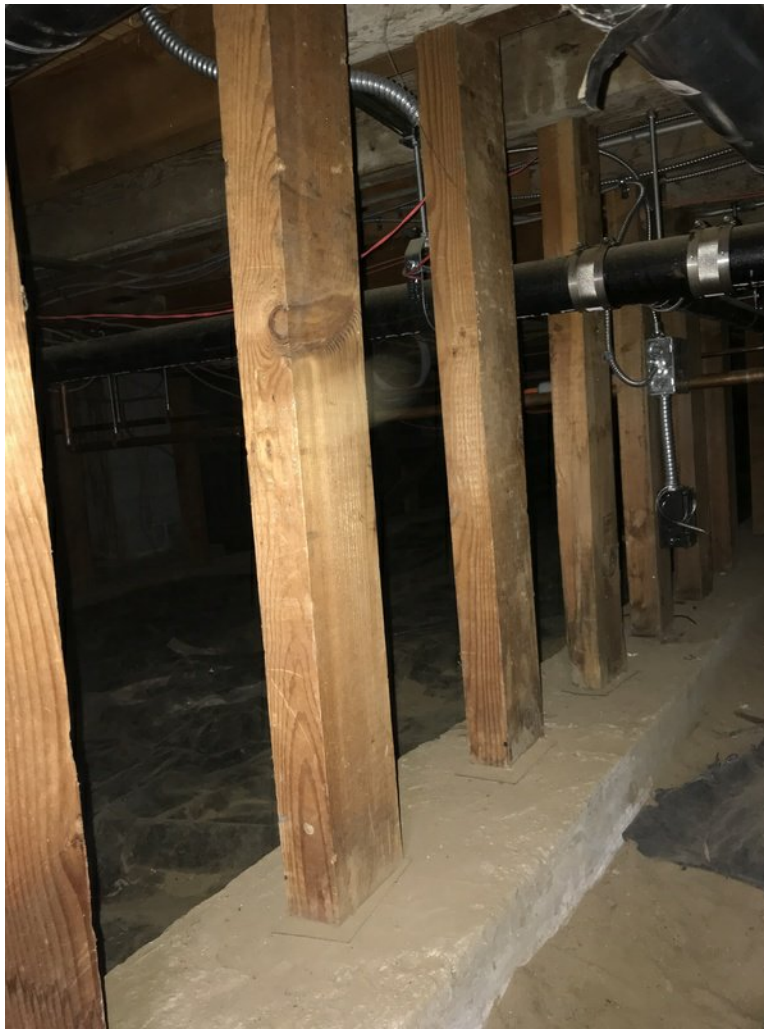
**Figure 1-5. Crawl space floor framing support on continuous footing**

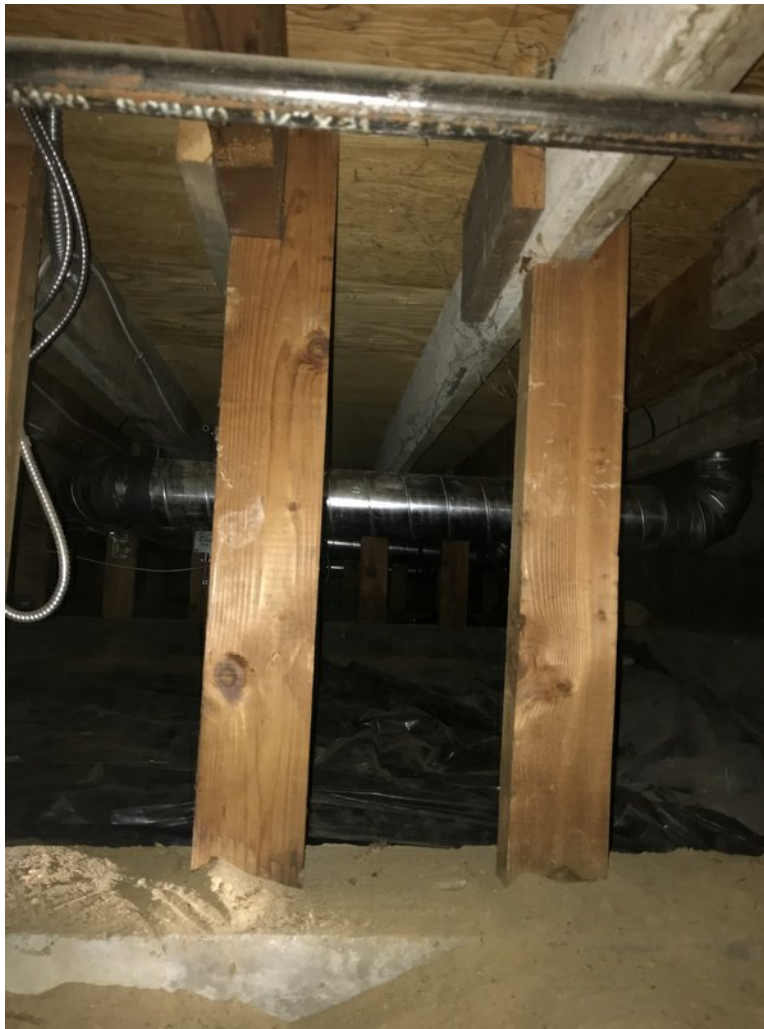
**Figure 1-6. Crawl space joist support at interior bearing**

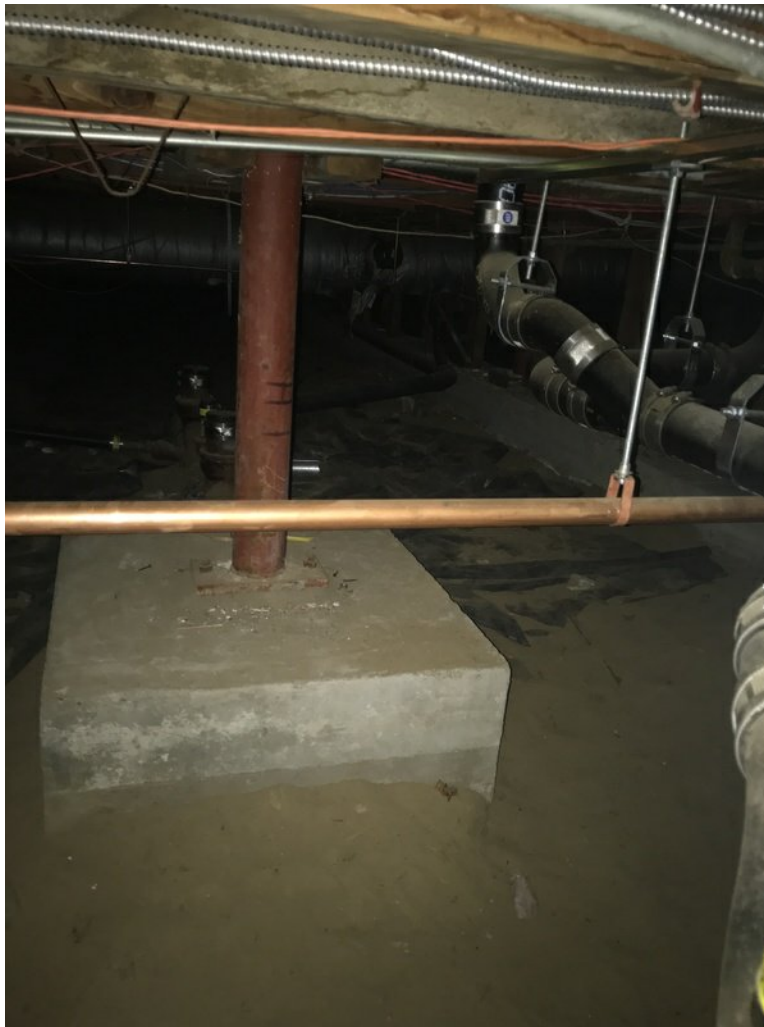
Figure 1-7. Floor framing support column and footing

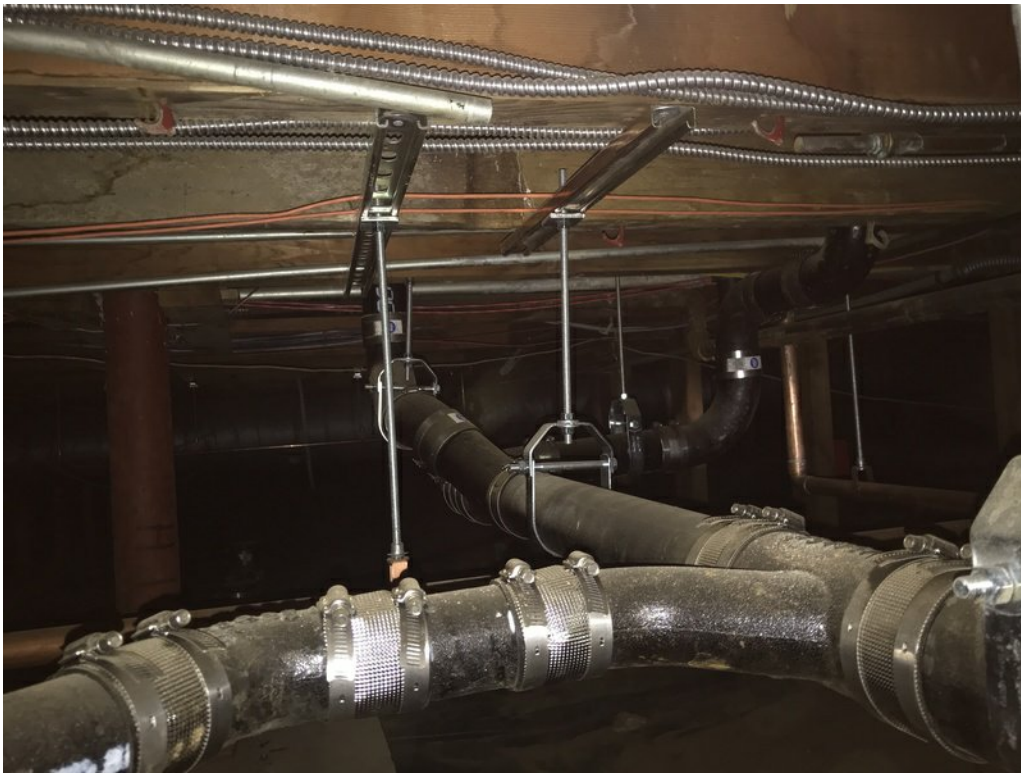
**Figure 1-8. Crawl space pipe support**

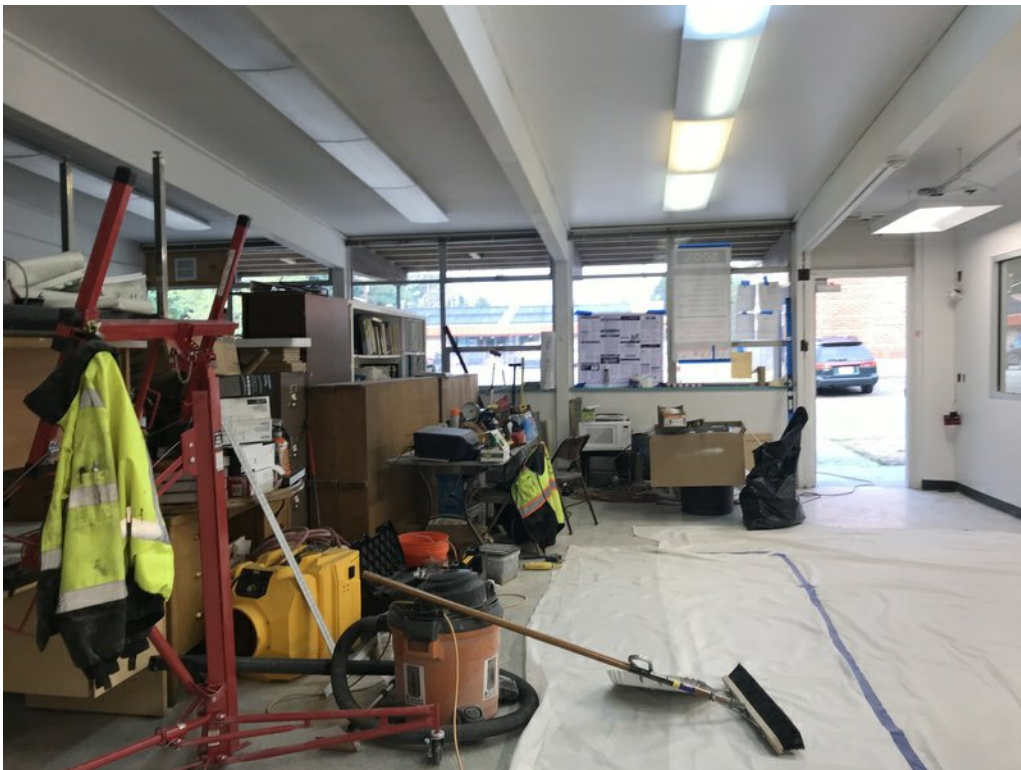
**Figure 1-9. Roof framing - (classroom under construction)**
